DIAGNOSE THE PROBLEM!

When an SBA-equipped brake is found to be beyond the adjustment limit, adjusting the SBA is only a **TEMPORARY MEASURE**.

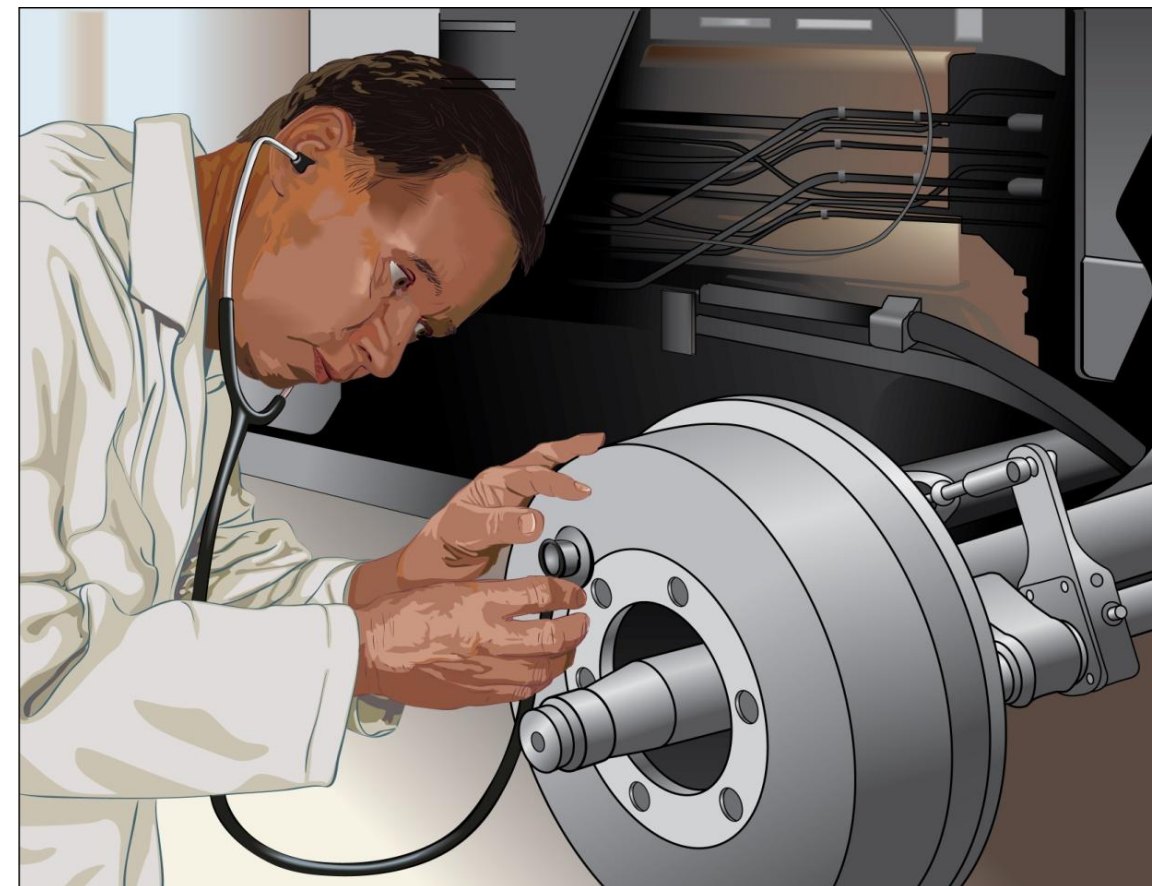
Plunger-Type SBA	Possible Worn Brake Components	Control Arm-Type SBA

Worn s-camshaft bushings
Broken or excessive deflection of chamber mounting brackets

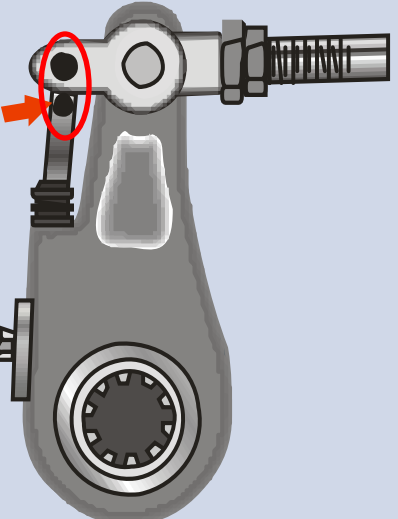
Pin missing from plunger connection	Control arm not connected

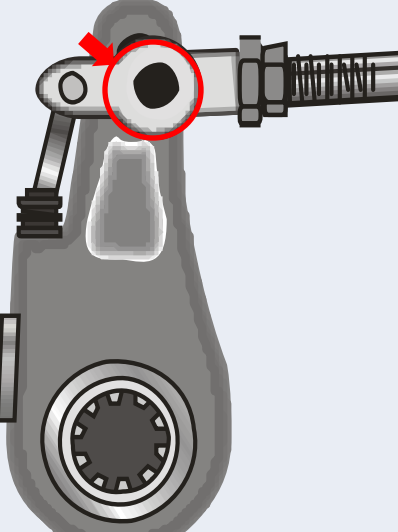
Pin missing from SBA arm connection	Wear in pin /clevis hole connection

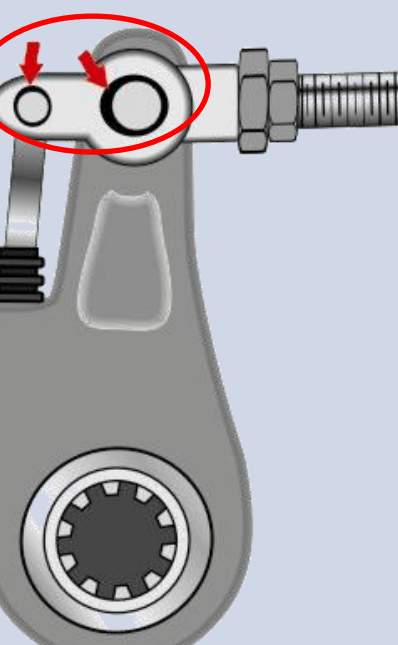
Wear of pin and/or clevis hole in plunger connection	Wear of pin connection to control arm, or control arm bushing missing
